# TEST REPORT

**Sample Name:** Find my dual tag  
**Trademark:** N/A  
**Model Number:** MO2759  
**Amount of sample:** 1pcs  
**Sample Received Date:** Dec. 19, 2025  
**Testing Period:** Dec. 19, 2025 - Dec. 26, 2025  
**Report No.:** SiCT2512241256S

Test Requested:	Test Sequence	Test Item
	1	IPX5 test

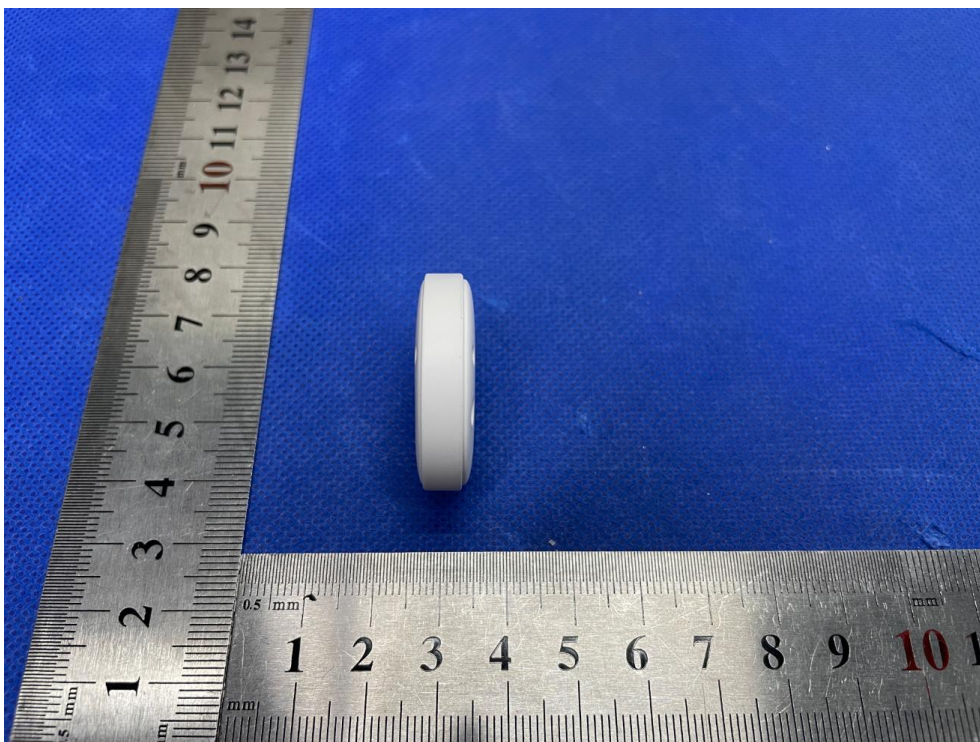
**SAMPLE PHOTO(S):**

Sample No.	Sample name	Test Results (visual observation)
01	Find my dual tag	No water entered into live parts of the sample, the sample passed the IPX5 test.
